Uses of Vegetative Measures for Erosion Mitigation in Mid Hill Areas of Nepal ^{*1}

Key words: erosion, revegetation technology, Mid hill, Nepal

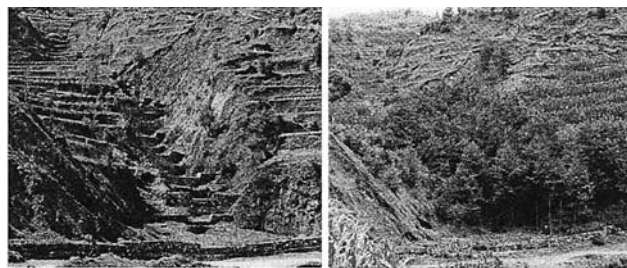
Photo-2. Glimpse of revegetation activities in landslide and gully control sites.

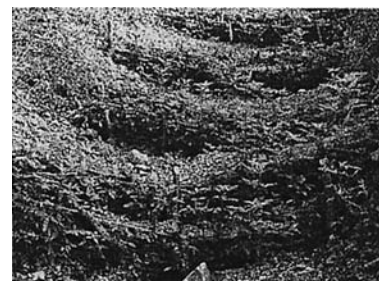
a. Live check dam

b. Configuration

Photo- 4. Live check dam and its configuration used for gully control.

In some gully areas, a live check dam was constructed from the variety of woody cutting to prevent and stabilize the gully erosion. The slope gradient of gully bed was 35°.
